Crystal Fire® Plus: Complete Troubleshooting Guide

For Crystal Fire® Plus burners that are exhibiting nuisance shutdowns, please follow this troubleshooting guide. A nuisance shutdown can be defined as any shutdown that is not initiated by the user. This can occur immediately upon startup or after approximately 20-30 minutes.

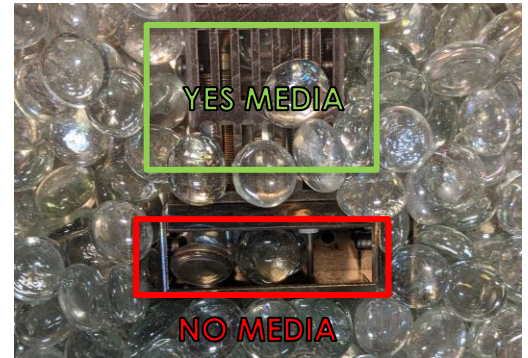
Image 1

1. When lighting the burner, ensure that the control knob is being fully depressed until it cannot move further. Partial engagement of the internal components due to a partially depressed knob can cause nuisance shutdowns.
2. Ensure that there is no media within the wind guard. See Image 1. If there is media present inside the wind guard, carefully remove it from the wind guard opening. Media can be present on the back cover of the wind guard.
3. Verify which version of the wind guard is installed on the burner. See Image 2.

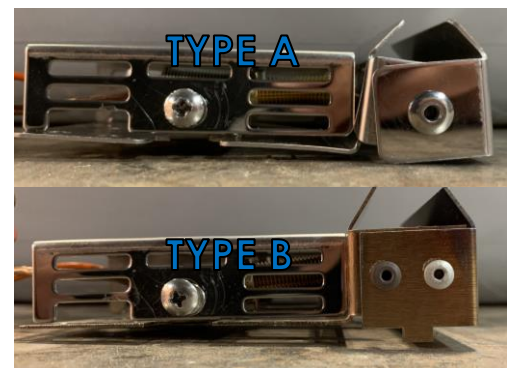
Image 2

If wind guard has one rivet on each side (Type A), continue with Step 3a. If wind guard has two rivets on each side (Type B), continue to Step 4.

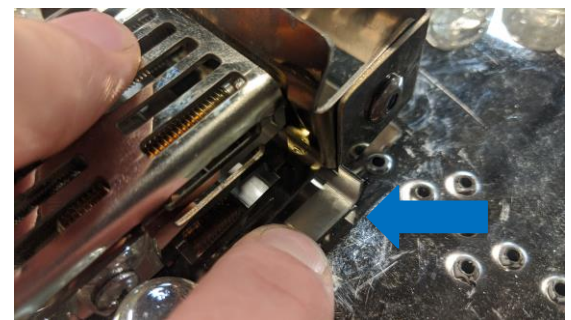
Image 3

- a. Is there a sheet metal riser clip installed under the wind guard? See Image 3. If yes, continue to Step 3b. If no, one must be sent out and installed. (P/N: 10316)
- b. Ensure that the clip is not covering any ports on the burner surface.
- c. Verify that the wind guard components are properly aligned to allow for a small gap at the front of the wind guard (~1/8"– 3/16"). See Image 4.

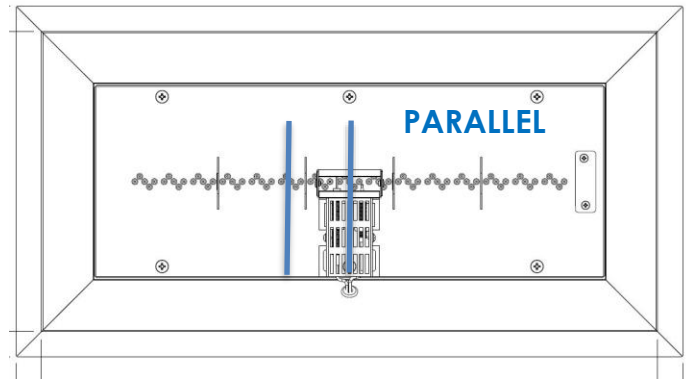
Image 5

4. Verify that wind guard is properly positioned on burner surface. Wind guard assembly should be parallel to wind fins on linear burners. See Image 5.
5. Check the entire length of the thermocouple for severe kinks or breakage. See Image 6. If damage has occurred to the thermocouple, a replacement thermocouple kit and instructions is available. (P/N: 70319)
6. Ensure that the thermocouple is properly tightened. A properly tightened thermocouple will have one thread exposed from the body of the control valve. See Image 7.
7. Verify that thermocouple is not contacting the wind guard in any location. The tip of the thermocouple should be centered in the hole of the wind guard. See Image 8.

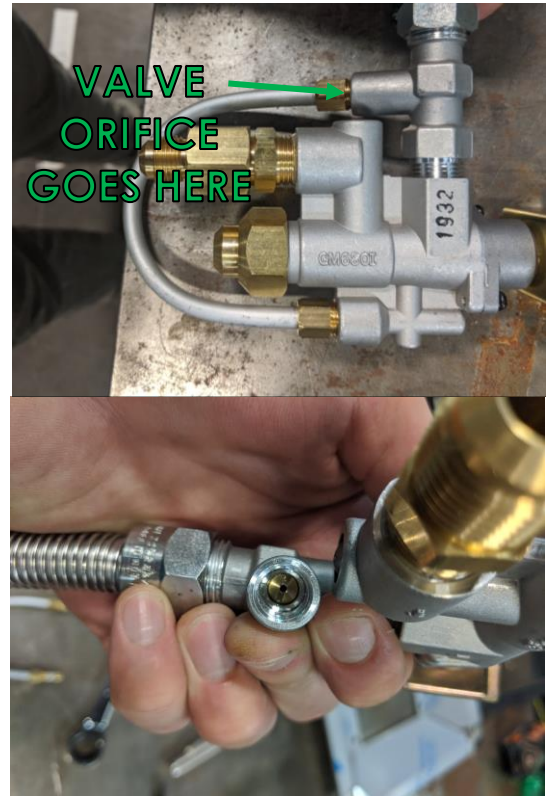
Image 9

8. Ensure burner is operating on the correct fuel type. Burners are set up standard for LP gas operation. Conversion to natural gas operation requires both the valve and burner orifice to change as well as closing the air shutter. See Image 9.
9. If Steps 1-7 have been completed and burner still shuts down after 20-30 minutes, check the outer surface of the LP tank after the burner shuts down. If there is frost on the tank, the overfill protection device of the tank has likely activated and caused the shutdown. See Image 10. This issue would be especially applicable to CFP1242 and CFP30 burners, which are larger burners.

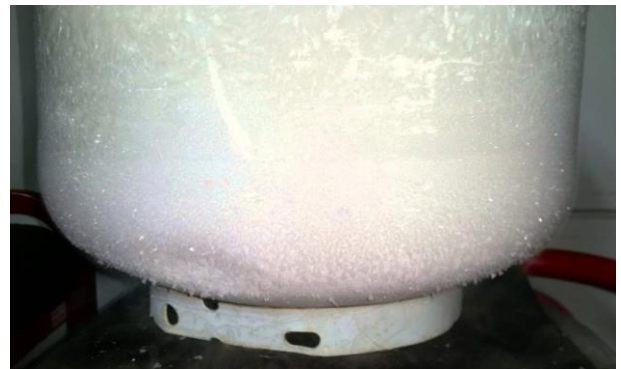
Image 10

This can be verified by listening to the control valve. If the flame goes out and is then followed by an audible click at the valve, this means that the LP tank caused the shutdown. If the flame goes out at the exact same time as the click at the valve, the system is still not receiving an adequate signal from the thermocouple. Follow the link or QR code below for a video demonstrating the "click".
